**Flood Control Project Maintenance
Levee Inspections**

Maintenance Issue Types Only, Levee Inspection Report By Mile - Spring 2015

San Joaquin County Flood Control and Water Conservation District

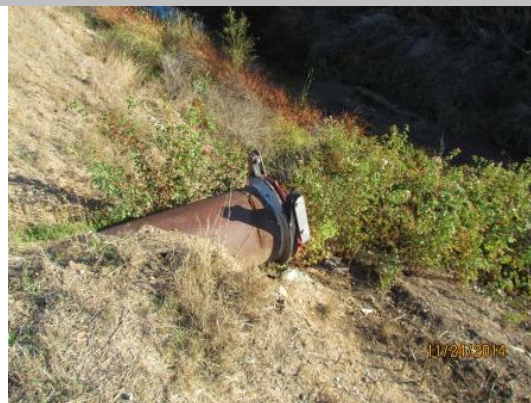
Photo 1 of 2 : SP_2015_NA0017_149_8_20150313_00005.jpg

LM Start	2.65	Rating **	A/W	Issue No.	8
LM End	2.65	Issue Type +	Ma	Location *	WS
Category	Earthen Levee			GPS Latitude/Longitude	
				Start	End
Item	Encroachments			37.888853 °	37.888853 °
				-121.258640 °	-121.258640 °
DWR ID	DWR_NA0017_02_s_2012_8				
Action/Comments					
Pipe Inspector Comments: Pipe crossing the channel has corroded and can carry water to/from the channel. A flap gate was installed by the LMA, but the pipe appeared to be damaged.

A flap gate was installed at the end of the pipe, but the pipe appeared to have cracks. The picture was taken from the crown looking upstream during fall 2014 inspection.

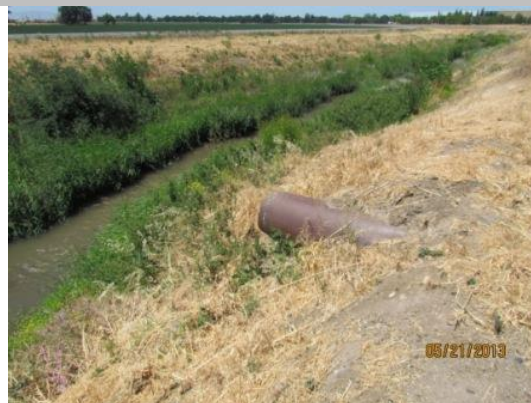
Photo 2 of 2 : SP_2015_NA0017_149_8_20150313_00006.jpg

A pipe was found without a flap gate on waterside slope of the levee looking downstream. This pipe may predate the project.

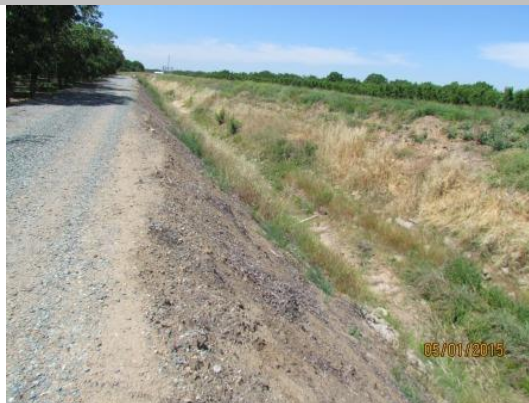
Photo 1 of 1 : SP_2015_NA0017_150_2_20150506_00001.jpg

View of waterside slope of the levee looking downstream.

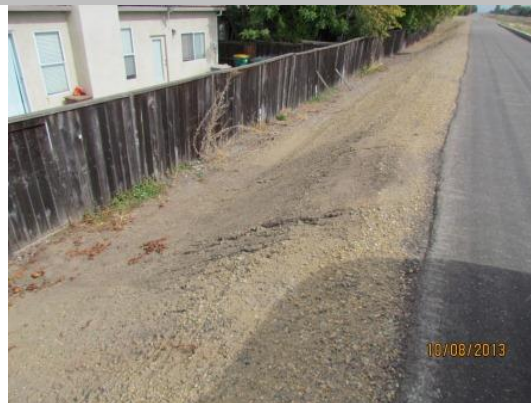
Photo 1 of 1 : SP_2015_NA0017_151_11_20150313_00004.jpg

LM Start	1.68	Rating **	M	Issue No.	11
LM End	1.68	Issue Type +	Ma	Location *	LS
Category	Earthen Levee			GPS Latitude/Longitude	
				Start	End
Item	Erosion / Bank Caving			38.043276 °	38.043276 °
				-121.342812 °	-121.342812 °
DWR ID	DWR_NA0017_07_f_2013_11				
Action/Comments					
Schedule repair of erosion site prior to the next inspection.					
Inspector Comments: Runoff on the landside slope.

Runoff was discovered on the landside slope of the levee looking upstream.

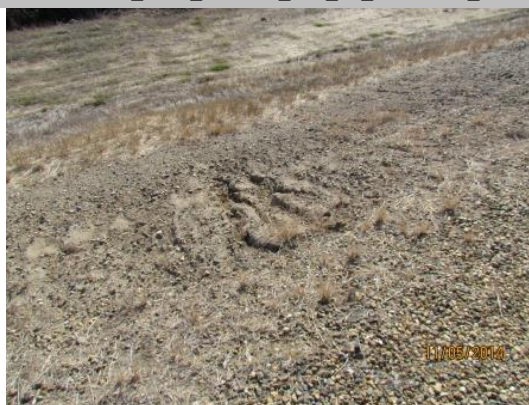
Photo 1 of 1 : SP_2015_NA0017_151_92_20150313_00040.jpg

LM Start	5.74	Rating **	M	Issue No.	92
LM End	5.74	Issue Type +	Ma	Location *	WS
Category	Earthen Levee			GPS Latitude/Longitude	
				Start	End
Item	Slope Stability			38.053335 °	38.053335 °
				-121.273287 °	-121.273287 °
DWR ID	DWR_NA0017_07_f_2014_92				
Action/Comments					
Repair the levee slope damaged by vehicle traffic and prevent access where possible.

Slope instability was found on the waterside of the levee looking downstream.

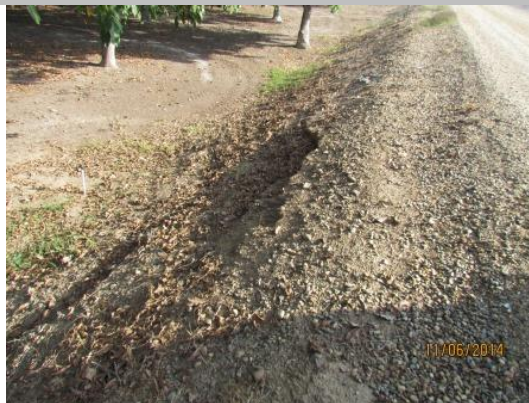
Photo 1 of 1 : SP_2015_NA0017_151_103_20150313_00049.jpg

View of a slope instability found on the landside of the levee looking upstream.

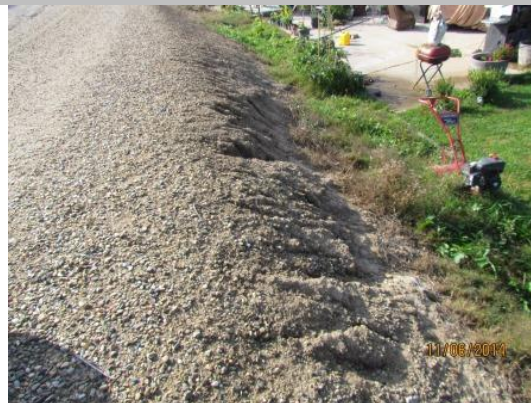
Photo 1 of 1 : SP_2015_NA0017_151_89_20150313_00039.jpg

View of erosion caused by runoff found on the landside slope of the levee looking downstream.

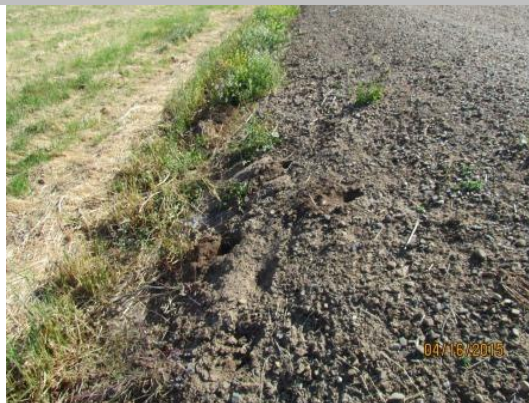
Photo 1 of 1 : SP_2015_NA0017_151_85_20150421_00067.jpg

Rodent holes were found on the landside of the levee looking upstream.

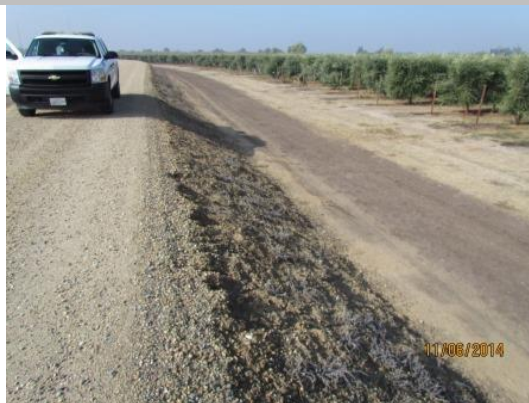
Photo 1 of 1 : SP_2015_NA0017_151_106_20150313_00052.jpg

Erosion caused by runoff was found on the landside slope of the levee looking downstream.

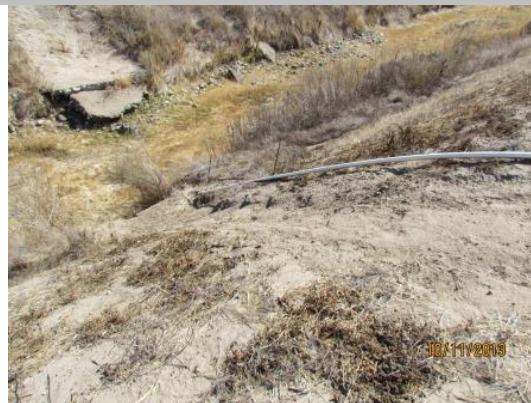
Photo 1 of 1 : SP_2015_NA0017_151_61_20150313_00028.jpg

Steps were found on the waterside slope of the levee looking downstream.

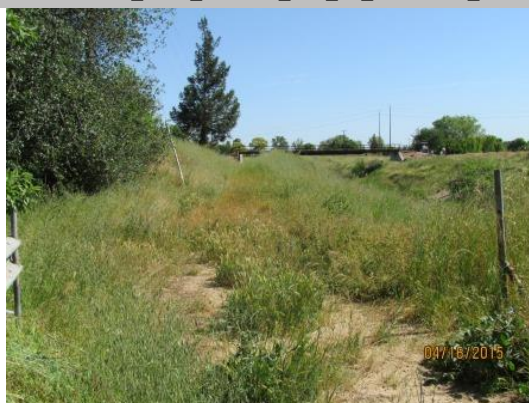
Photo 1 of 1 : SP_2015_NA0017_151_84_20150421_00069.jpg

Vegetation was found on the crown of the levee looking upstream.

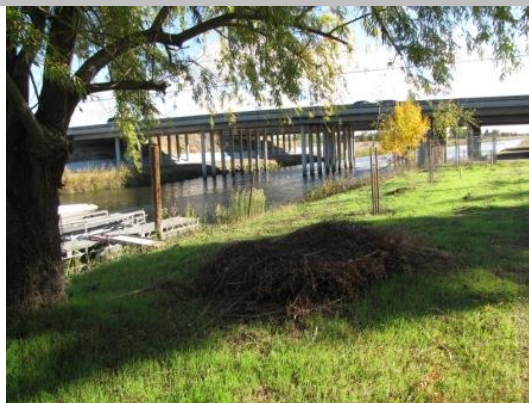
Photo 1 of 1 : SP_2015_NA0017_152_2_20150313_00002.jpg

View of a prunings pile on the waterward berm looking upstream.

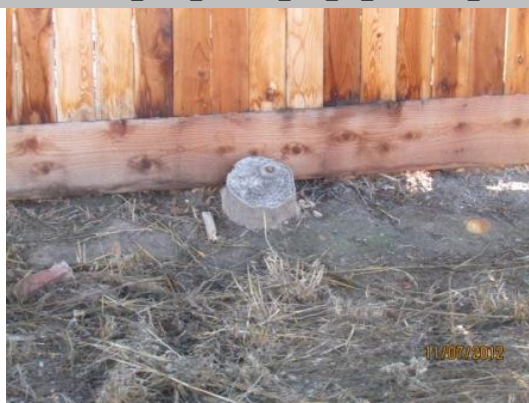
Photo 1 of 1 : SP_2015_NA0017_152_18_20150313_00007.jpg

View of a tree stump that was found on the landside toe of the levee. The picture was taken from the crown looking towards the toe.

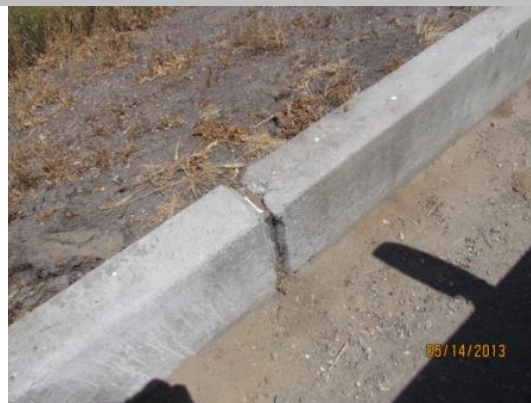
Photo 1 of 1 : SP_2015_NA0017_152_37_20150313_00015.jpg

The monolith joint material is deteriorating at this location of the flood wall. The picture was taken from the crown looking upstream.

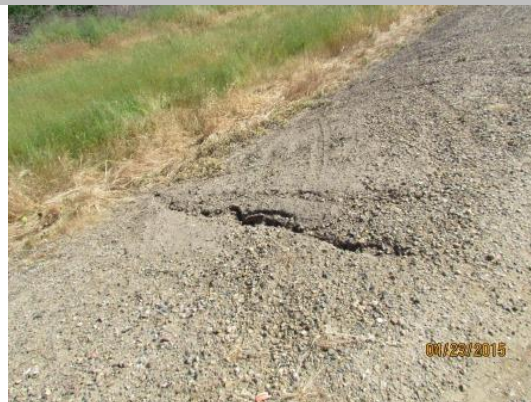
Photo 1 of 1 : SP_2015_NA0017_152_6_20150429_00115.jpg

View of a slope instability due to runoff on the waterside of the levee looking upstream.

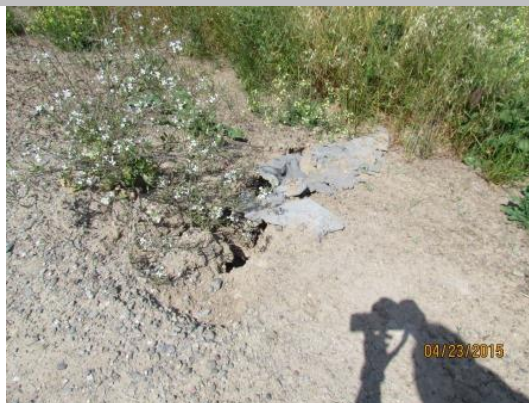
Photo 1 of 1 : SP_2015_NA0017_152_111_20150429_00121.jpg

View of slope instability due to rodent holes on the waterside of the levee looking downstream.

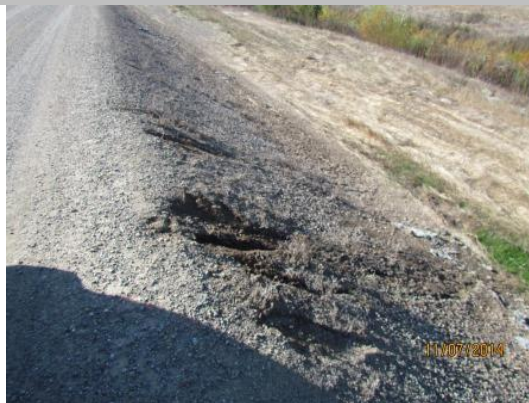
Photo 1 of 1 : SP_2015_NA0017_152_74_20150313_00029.jpg

A slope instability was found on the waterside of the levee looking downstream.

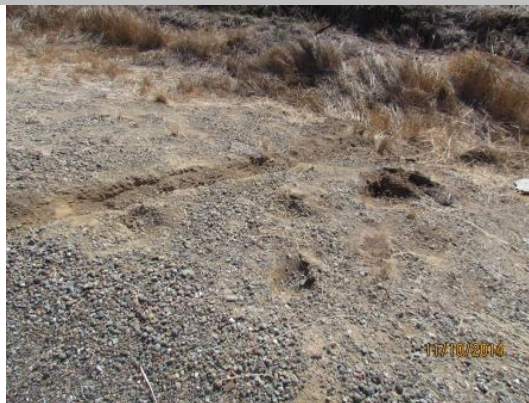
Photo 1 of 1 : SP_2015_NA0017_152_130_20150313_00049.jpg

A slope instability was found on the landside of the levee looking upstream.

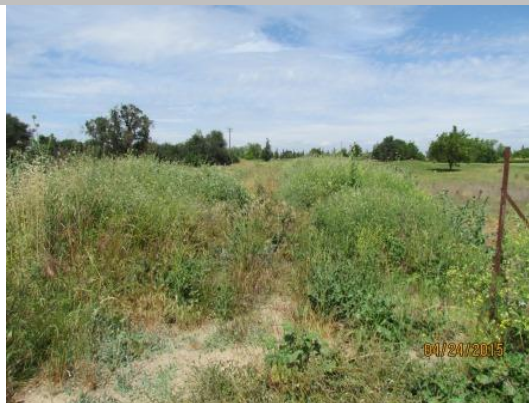
Photo 1 of 1 : SP_2015_NA0017_152_80_20150429_00122.jpg

View of vegetation along the crown of the levee looking upstream.

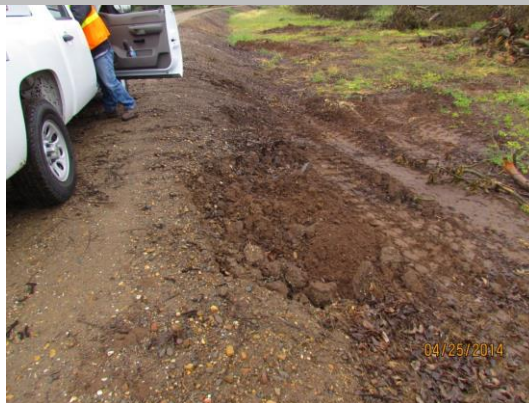
Photo 1 of 1 : SP_2015_NA0017_152_86_20150313_00033.jpg

Slope instability was found on landside toe of the levee looking upstream.

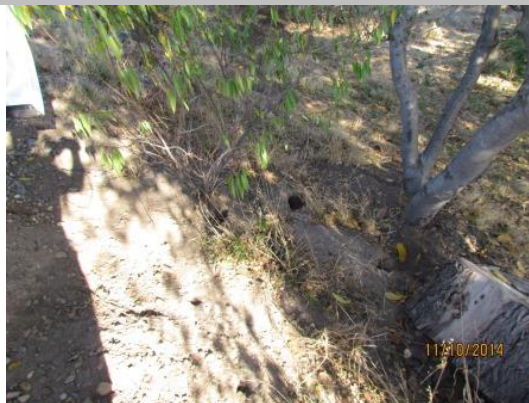
Photo 1 of 1 : SP_2015_NA0017_152_132_20150313_00050.jpg

Rodent holes were found on the landside of the levee looking upstream.

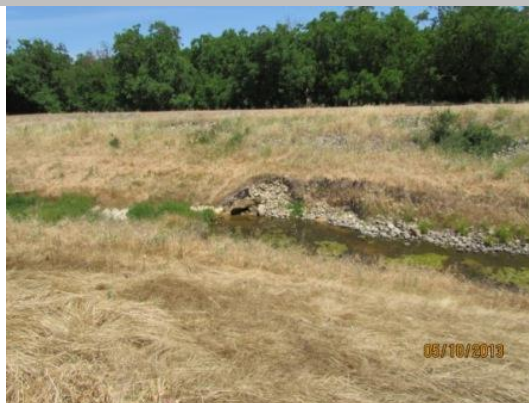
Photo 1 of 1 : SP_2015_NA0017_152_89_20150313_00035.jpg

Erosion was found on the waterside toe of the levee. The picture was taken from the opposite side of the levee.

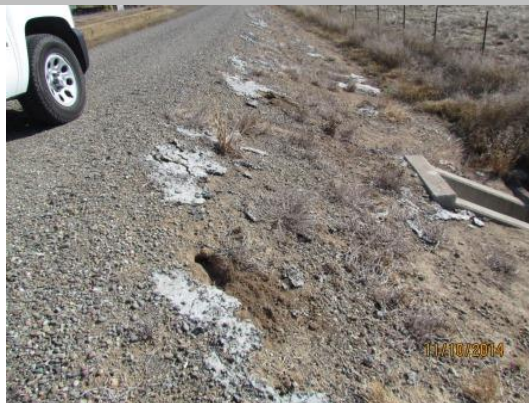
Photo 1 of 1 : SP_2015_NA0017_153_5_20150313_00002.jpg

View of rodent holes that were found on the landside of the levee looking upstream.

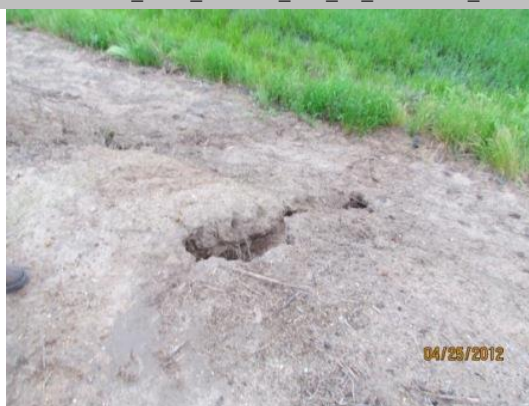
Photo 2 of 2 : SP_2015_NA0017_156_12_20150313_00011.jpg

View of erosion that was found on the waterside of the levee looking downstream.

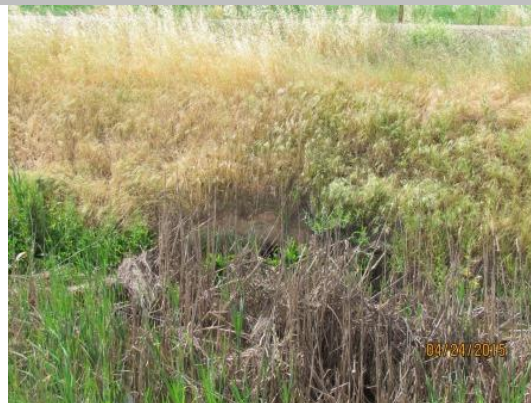
Photo 1 of 1 : SP_2015_NA0017_157_5_20150429_00007.jpg

View of a beaver den on the waterside toe of the levee. The picture was taken across the levee.

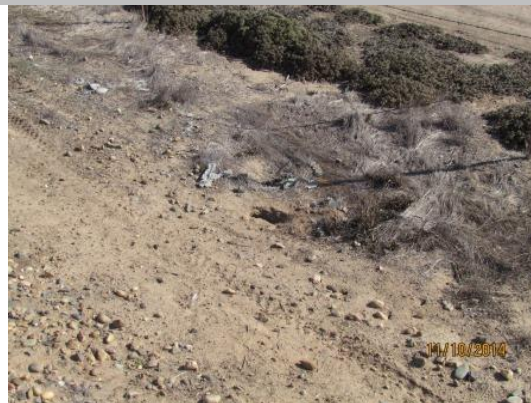
Photo 1 of 1 : SP_2015_NA0017_157_8_20150313_00005.jpg

View of an animal hole that was found on the landside of the levee looking upstream.

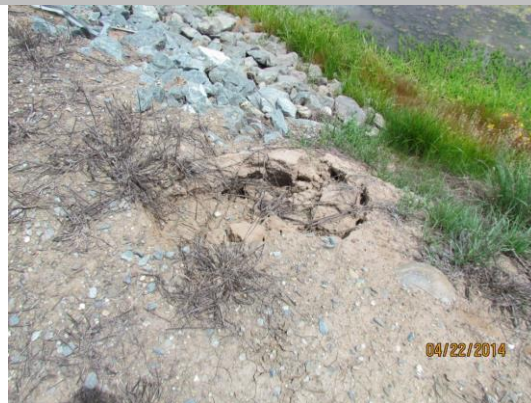
Photo 1 of 2 : SP_2015_NA0017_158_8_20150313_00009.jpg

Updated picture of the rodent hole on the waterside shoulder of the levee looking upstream during the spring 2014 inspection.

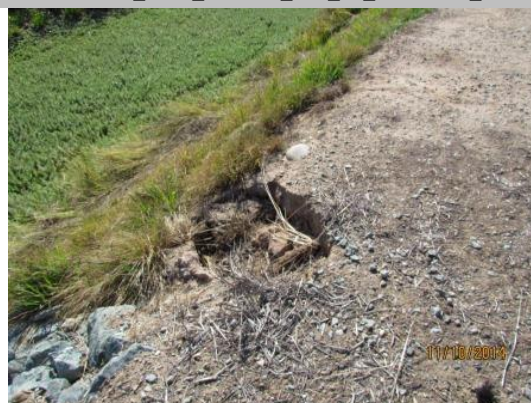
Photo 1 of 1 : SP_2015_NA0017_158_13_20150313_00011.jpg

View of a slope instability that was found on the waterside shoulder of the levee looking downstream.

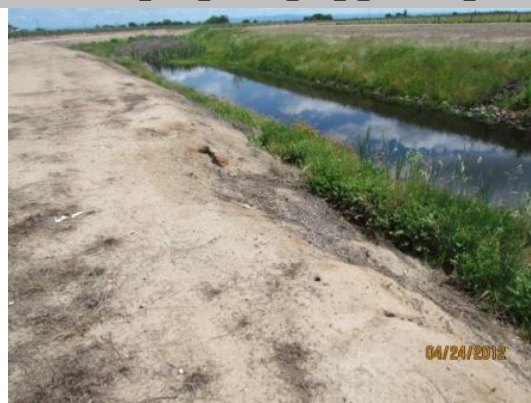
Photo 1 of 2 : SP_2015_NA0017_158_4_20150313_00004.jpg

View of erosion that was found on the waterside of the levee looking upstream. This picture was taken during spring 2012 inspection.

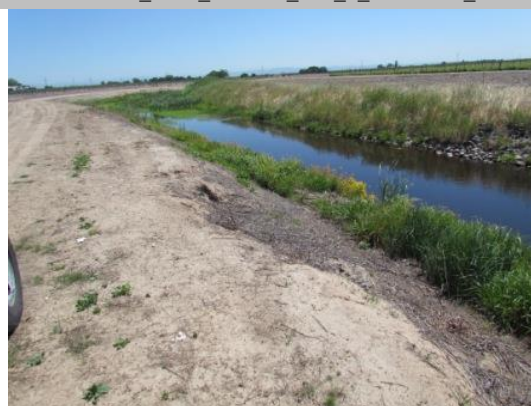
Photo 2 of 2 : SP_2015_NA0017_158_4_20150313_00005.jpg

View of erosion that was found on the waterside of the levee.

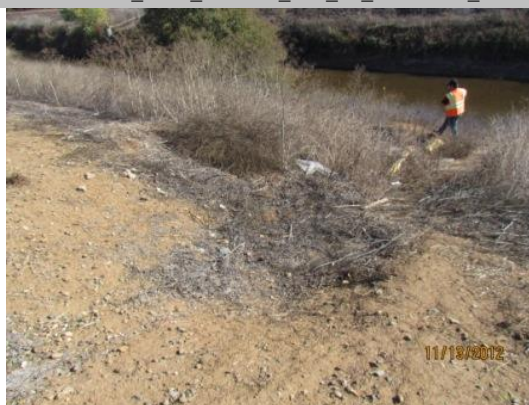
Photo 1 of 2 : SP_2015_NA0017_159_18_20150313_00009.jpg

Updated picture of the slope instability at the waterside slope of the levee looking upstream.

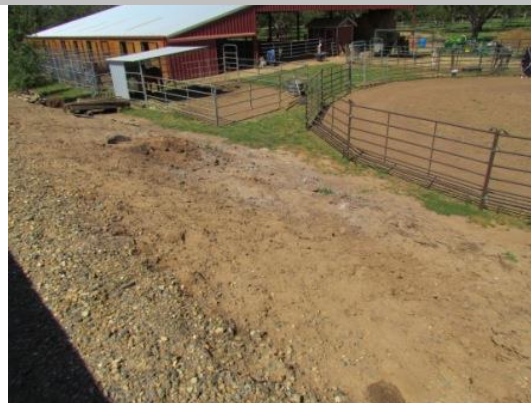
Photo 1 of 1 : SP_2015_NA0017_159_27_20150313_00018.jpg

Slope instability was found on the landside of the levee. The picture was taken from the crown looking downstream.

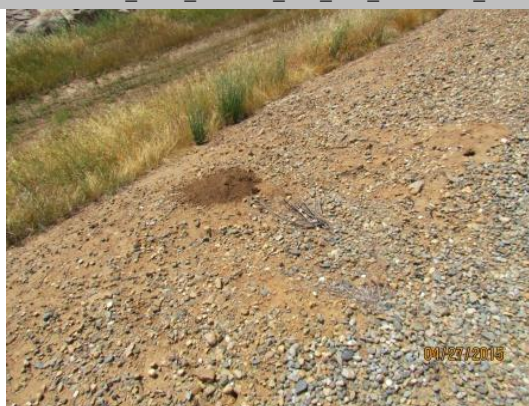
Photo 1 of 1 : SP_2015_NA0017_159_134_20150429_00133.jpg

Rodent holes were found on the waterside of the levee looking downstream.

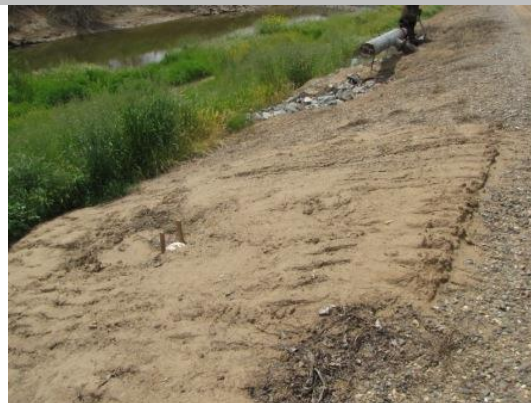
Photo 1 of 1 : SP_2015_NA0017_159_54_20150313_00040.jpg

View of a recently placed pipe in the waterward slope looking downstream.

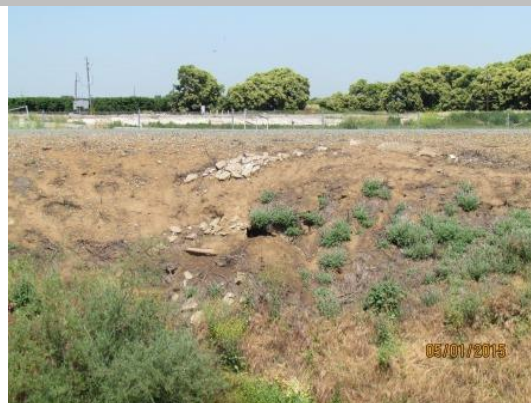
Photo 1 of 1 : SP_2015_NA0017_159_208_20150501_00148.jpg

A rodent hole was found on the waterside of the levee. The picture was taken from the opposite side of the levee.

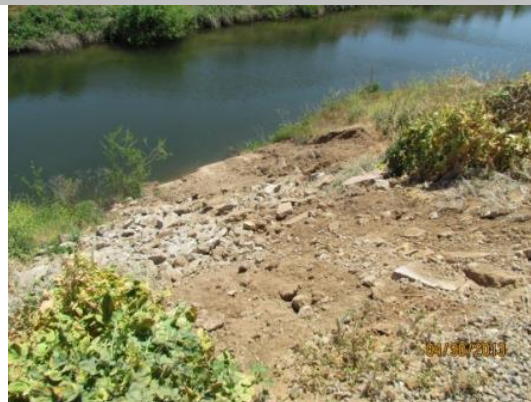
Photo 1 of 2 : SP_2015_NA0017_159_43_20150313_00028.jpg

Updated picture of the slope instability on the waterside slope of the levee looking downstream.

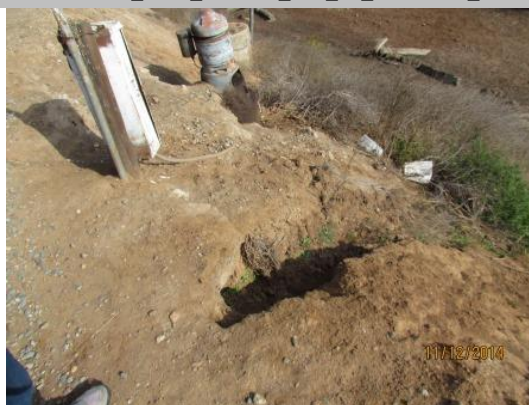
Photo 1 of 4 : SP_2015_NA0017_159_44_20150313_00030.jpg

Updated picture of the slope instability on the waterside slope of the levee looking upstream. This picture was taken during fall 2014 inspection.

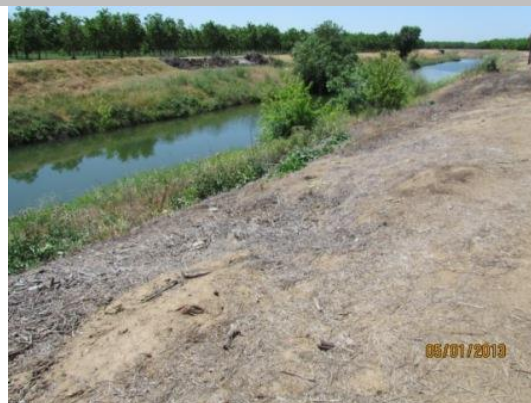
Photo 1 of 1 : SP_2015_NA0017_159_121_20150313_00081.jpg

A slope instability was found on the waterside slope of the levee looking downstream.

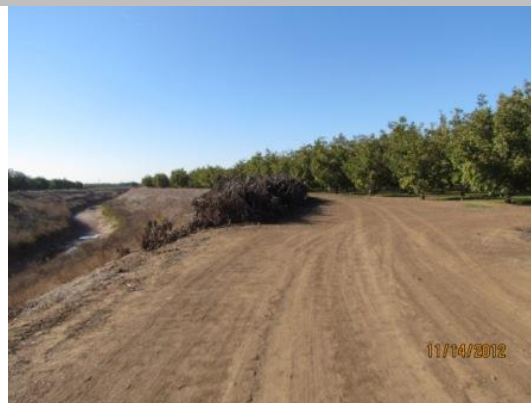
Photo 1 of 1 : SP_2015_NA0017_159_147_20150313_00091.jpg

Prunings were found on the waterside shoulder of the levee looking downstream.

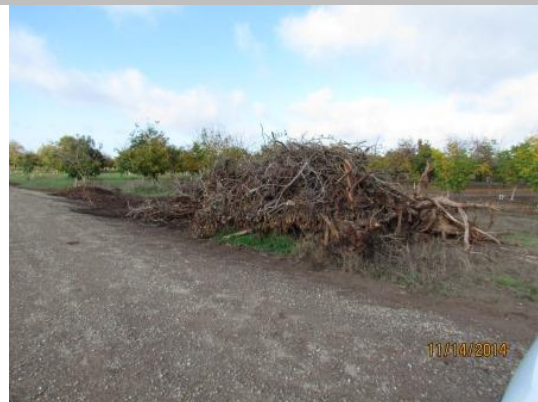
Photo 1 of 1 : SP_2015_NA0017_159_106_20150313_00073.jpg

Prunings were found on the landside of the levee looking downstream.

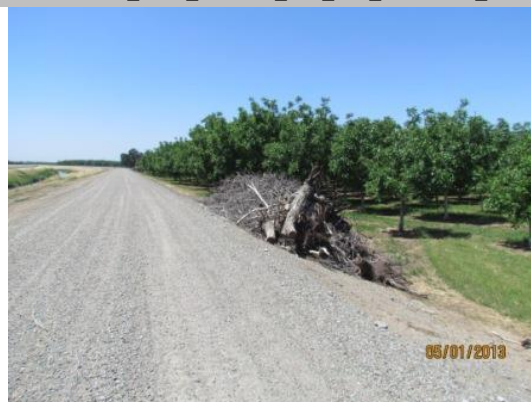
Photo 1 of 1 : SP_2015_NA0017_159_989_20150313_00112.jpg

Prunings were found on the landside slope of the levee looking downstream.

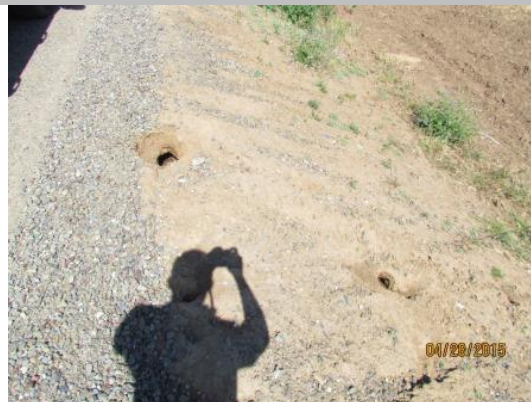
Photo 1 of 1 : SP_2015_NA0017_159_194_20150429_00140.jpg

Rodent holes were found on the landside of the levee looking downstream.

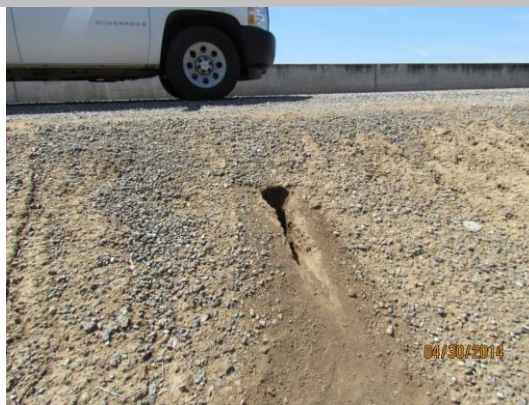
Photo 2 of 2 : SP_2015_NA0017_159_32_20150313_00022.jpg

A rodent hole was found on the landside of the levee looking downstream.

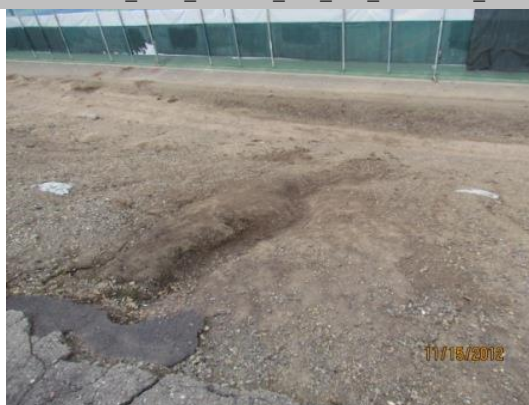
Photo 3 of 3 : SP_2015_NA0017_159_173_20150313_00100.jpg

Updated picture of the erosion located on the landside of the levee looking downstream.

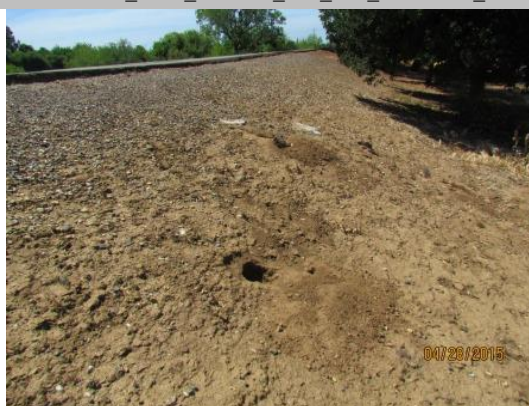
Photo 1 of 1 : SP_2015_NA0017_159_185_20150429_00145.jpg

Rodent holes were found on the landside of the levee looking downstream.

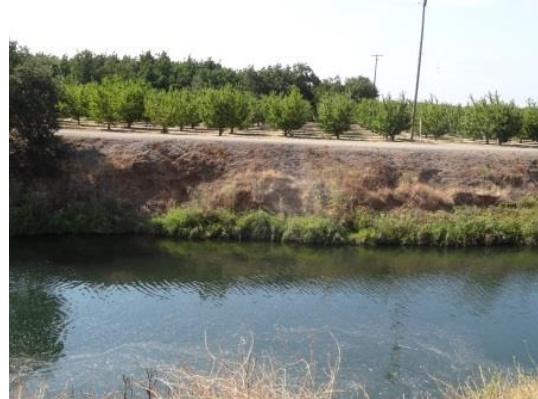
Photo 1 of 1 : SP_2015_NA0017_160_269_20150313_00156.jpg

Front view of the erosion.

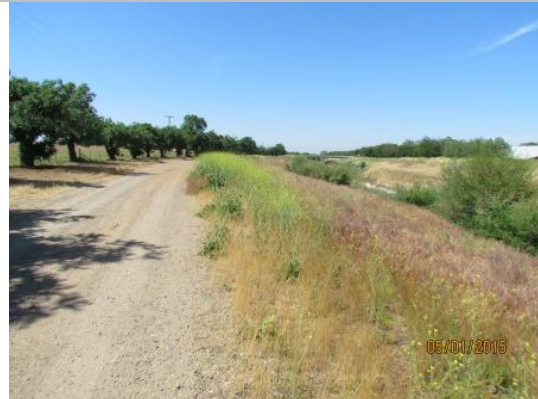
Photo 1 of 1 : SP_2015_NA0017_160_239_20150506_00162.jpg

View of vegetation along waterside looking downstream.

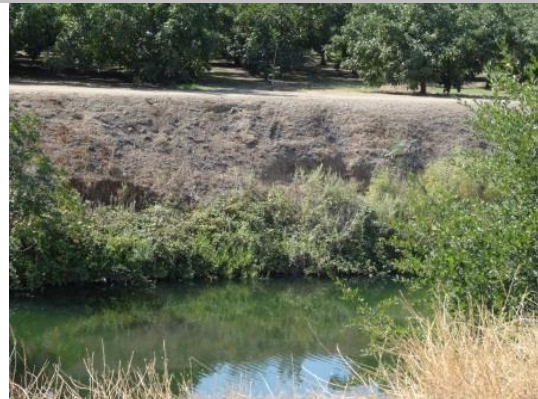
Photo 1 of 1 : SP_2015_NA0017_160_223_20150313_00141.jpg

Close view of the pocket erosion.

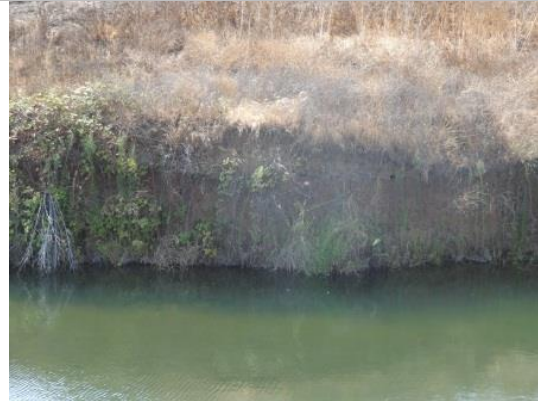
Photo 1 of 1 : SP_2015_NA0017_160_222_20150313_00140.jpg

Front view of the erosion site.

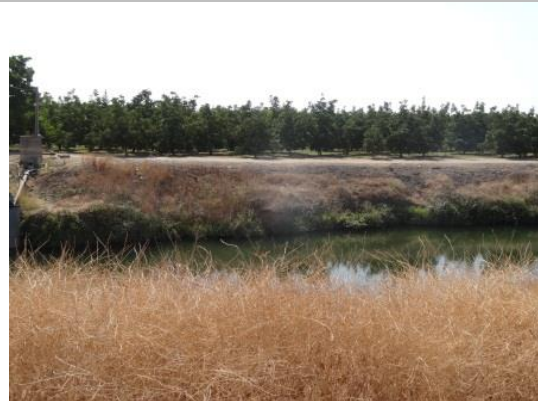
Photo 1 of 1 : SP_2015_NA0017_160_219_20150313_00139.jpg

Looking at the erosion from right river bank.

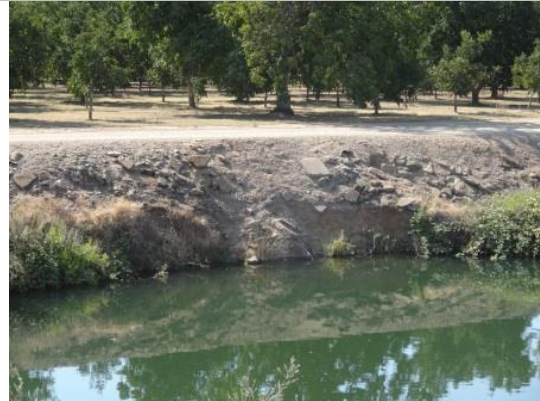
Photo 1 of 1 : SP_2015_NA0017_160_214_20150313_00135.jpg

Close view of the erosion. Note the vegetation at the site.

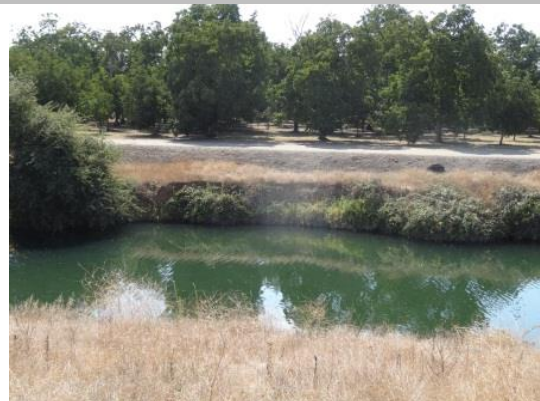
Photo 1 of 1 : SP_2015_NA0017_160_215_20150313_00136.jpg

Closer view of the erosion.

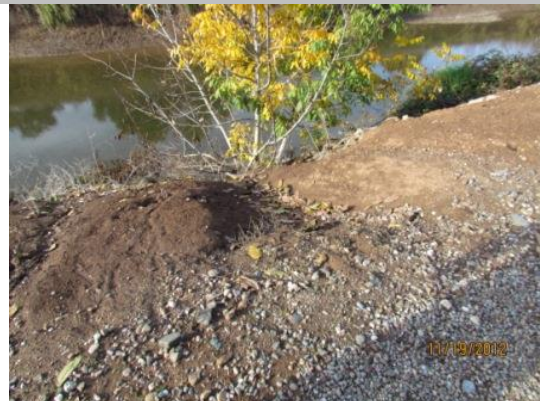
Photo 1 of 2 : SP_2015_NA0017_160_213_20150313_00133.jpg

Updated picture of the slope instability on the waterside shoulder of the levee looking upstream.

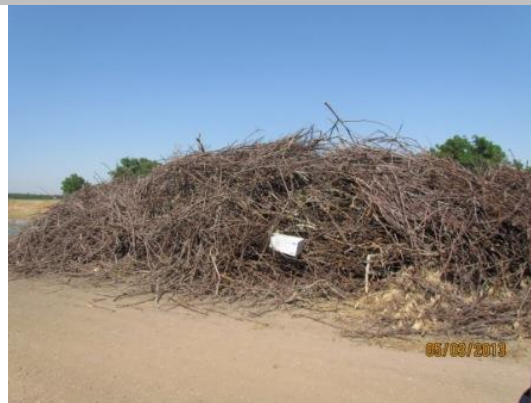
Photo 1 of 1 : SP_2015_NA0017_160_53_20150313_00027.jpg

Prunings were found on the waterside shoulder of the levee looking downstream.

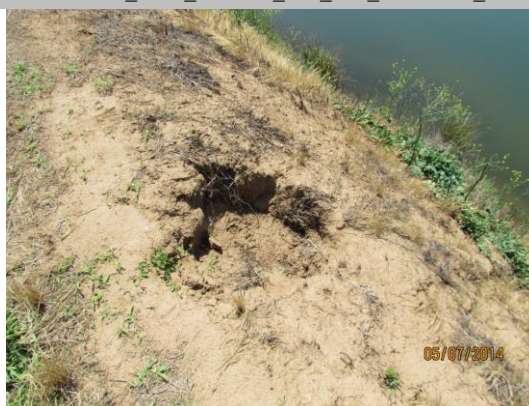
Photo 1 of 1 : SP_2015_NA0017_160_141_20150313_00084.jpg

A slope instability was found on the waterside of the levee looking downstream.

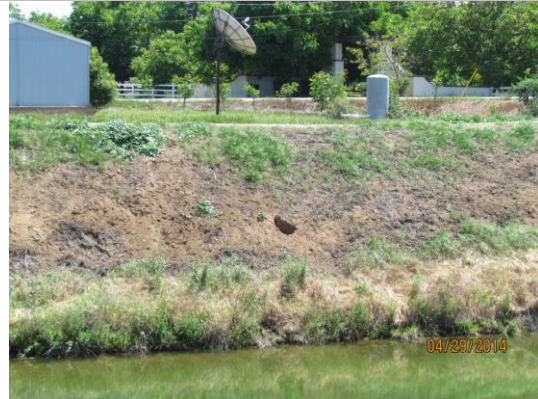
Photo 1 of 1 : SP_2015_NA0017_160_50_20150313_00025.jpg

View of a rodent hole on the waterside slope of the levee. The picture was taken from the opposite side of the levee.

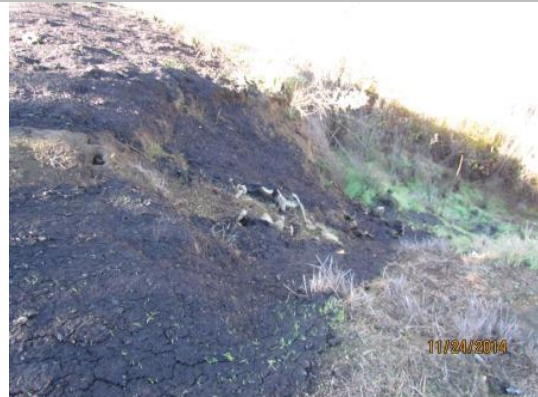
Photo 1 of 2 : SP_2015_NA0017_160_120_20150313_00066.jpg

Updated picture of the slope instability on the waterside of the levee looking downstream.

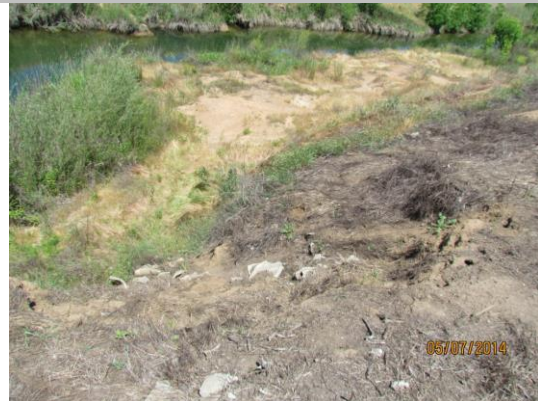
Photo 2 of 2 : SP_2015_NA0017_160_120_20150313_00067.jpg

Slope instability was found on the waterside of the levee looking upstream.

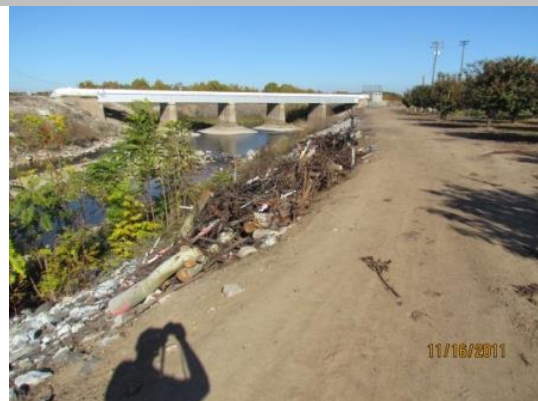
Photo 1 of 1 : SP_2015_NA0017_160_61_20150313_00033.jpg

Debris and prunings were found on the waterside of the levee looking upstream.

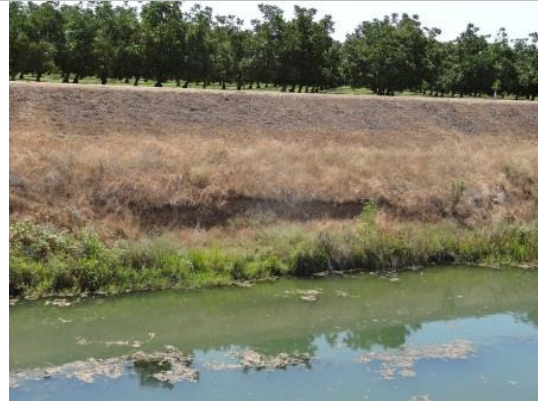
Photo 1 of 1 : SP_2015_NA0017_160_165_20150313_00099.jpg

Front view of the erosion.

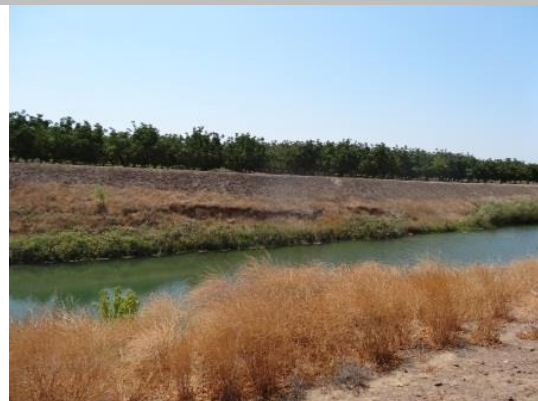
Photo 1 of 1 : SP_2015_NA0017_160_163_20150313_00097.jpg

Upstream view of the erosion.

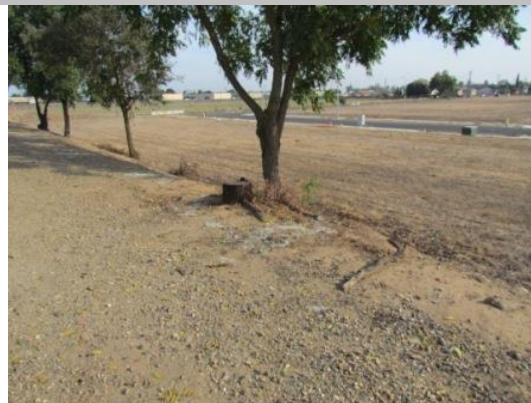
Photo 1 of 1 : SP_2015_NA0017_160_65_20150313_00035.jpg

A tree stump was found on the landside of the levee looking upstream.

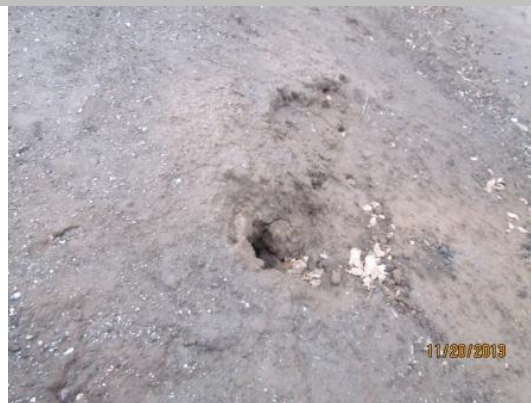
Photo 2 of 2 : SP_2015_NA0017_160_83_20150313_00046.jpg

A rodent hole was found on the landside of the levee looking upstream.

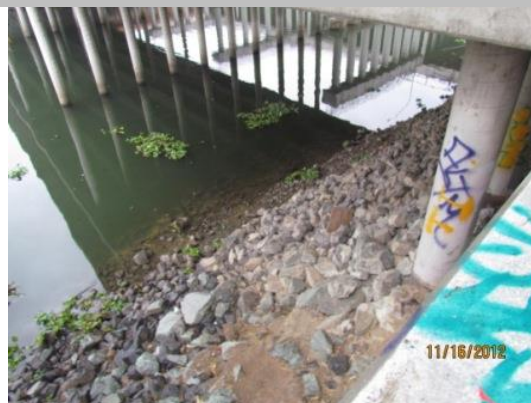
Photo 4 of 6 : SP_2015_NA0017_160_48_20150313_00022.jpg

Updated view of the erosion site repaired by Caltrans on the waterside slope of the levee looking upstream.
